Working with Eurasian beavers (*Castor fiber*) to deliver conservation management in a constrained landscape

RSPB Loch of Kinnordy

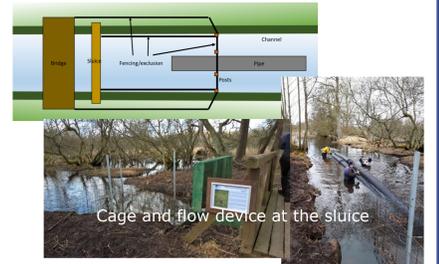
Cage and flow device at the sluice

Beavers first dammed against the sluice in 2014, effectively making the sluice redundant. Over the years Kinnordy Estate (the landowner) has raised concerns about the impact of high-water levels on adjacent fields, flooding of paths and limiting access. RSPB were concerned about losing the ability for late summer drawdown impacting site management activities. In September 2014 (under license) the dam at the sluice was removed. Following this, there was a cycle of rebuilding by the Beavers and removal by RSPB, leading to installation of a Beaver flow device and cage structure designed in collaboration with SNH and Roisin Campbell-Palmer. Following installation of the cage and flow device, Beavers then moved their damming activity further along the outflow and excavated an old outflow channel which effectively acts as a by-pass to the sluice. Additional flow devices have been installed and there has been periodic dam management by removal and notching (all work carried out under license).

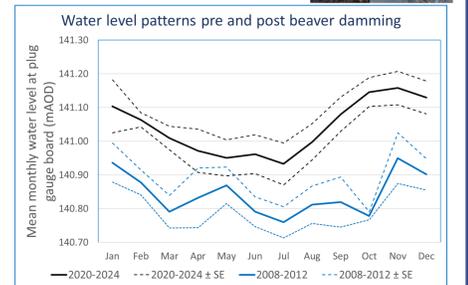
Water level patterns pre and post beaver damming

Water levels are higher overall and more stable over spring and summer than prior to Beaver damming on-site. Water level is determined by rainfall, Beaver activity and to a lesser extent our management of Beaver dams. Without the presence of Beaver dams, it would now be difficult to maintain water levels during the bird breeding season, as water can exit the site through routes other than those where the sluice is.

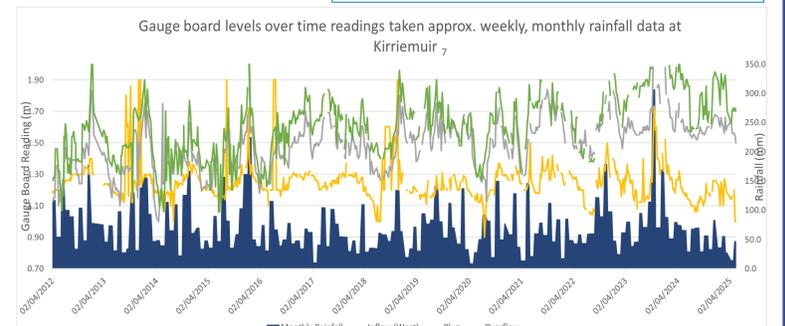
Gauge board levels over time readings taken approx. weekly, monthly rainfall data at Kirriemuir
