# Beaver burrowing activity along the River Isla in Scotland

Survey methods and burrowing patterns

## Surveyed 22km riverbank in Isla river

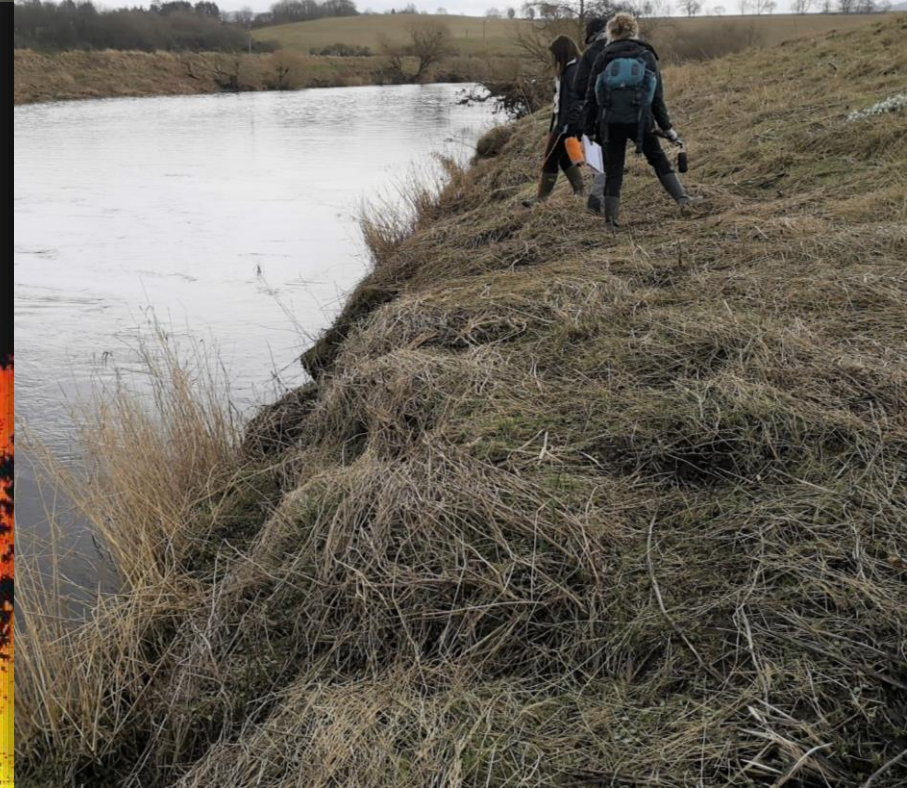
Scalar field = 326.60

X	4.67	Xg	321304.67	R	255
Y	-20.48	Yg	740579.52	G	121
Z	30.19	Zg	30.19	B	0

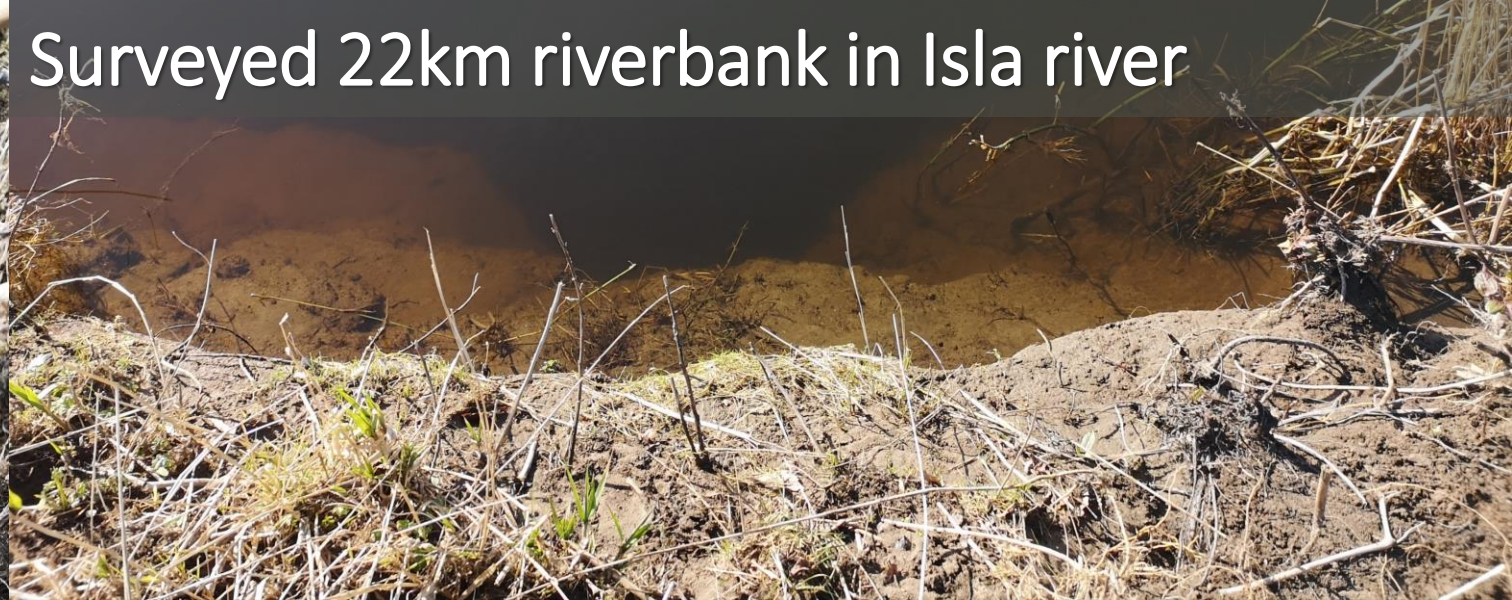
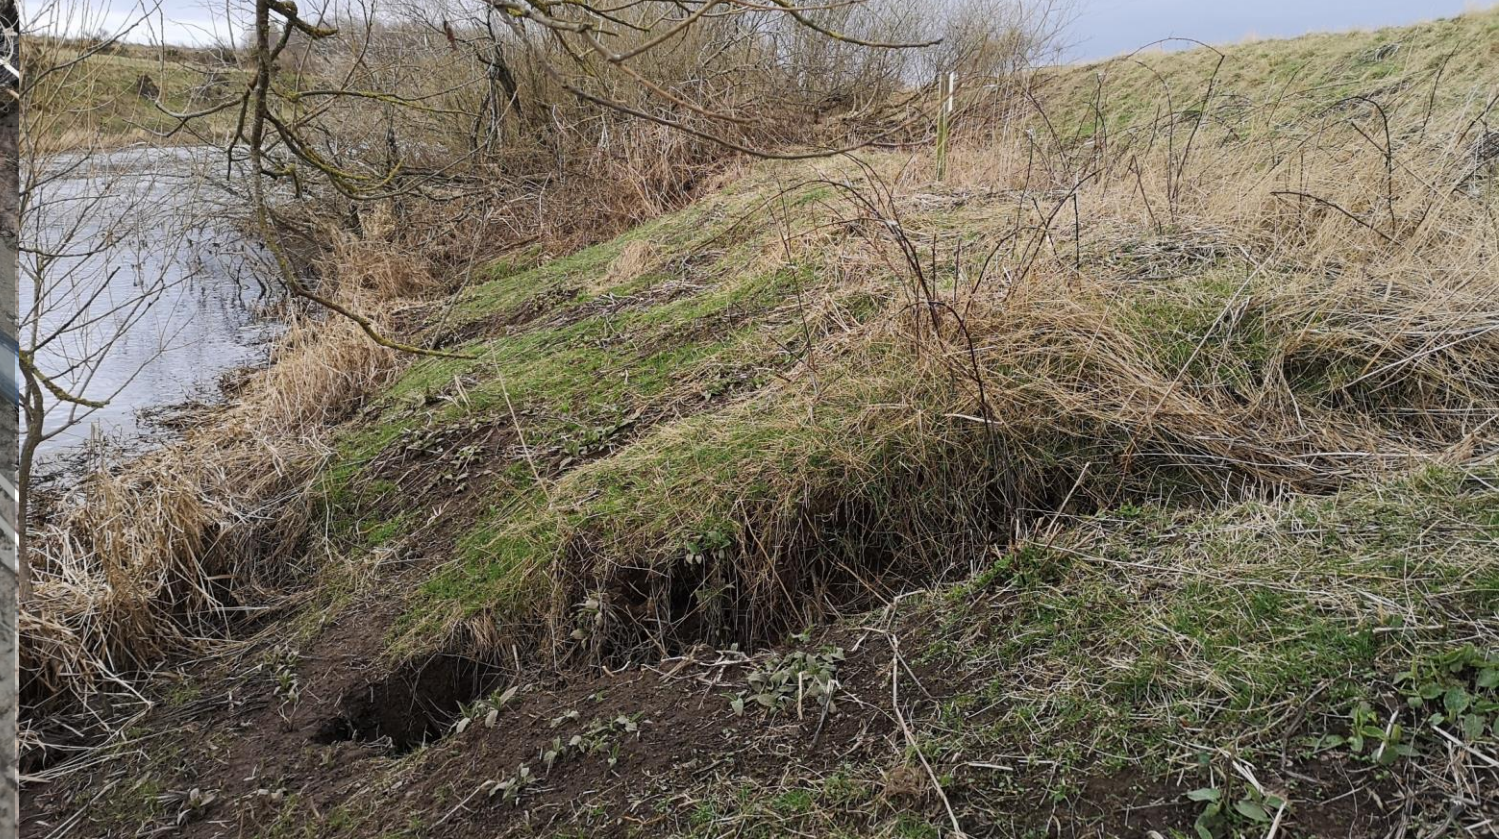
Sonar  
LiDAR  
Foot – intact  
Foot – collapsed  
Foot – possible  
Not surveyed on foot

Southwest half of survey area

*(note this part of the survey area contained the majority of burrows recorded)*

Burrows are not more common on outside of meanders

Collapsed burrows are highly aggregated

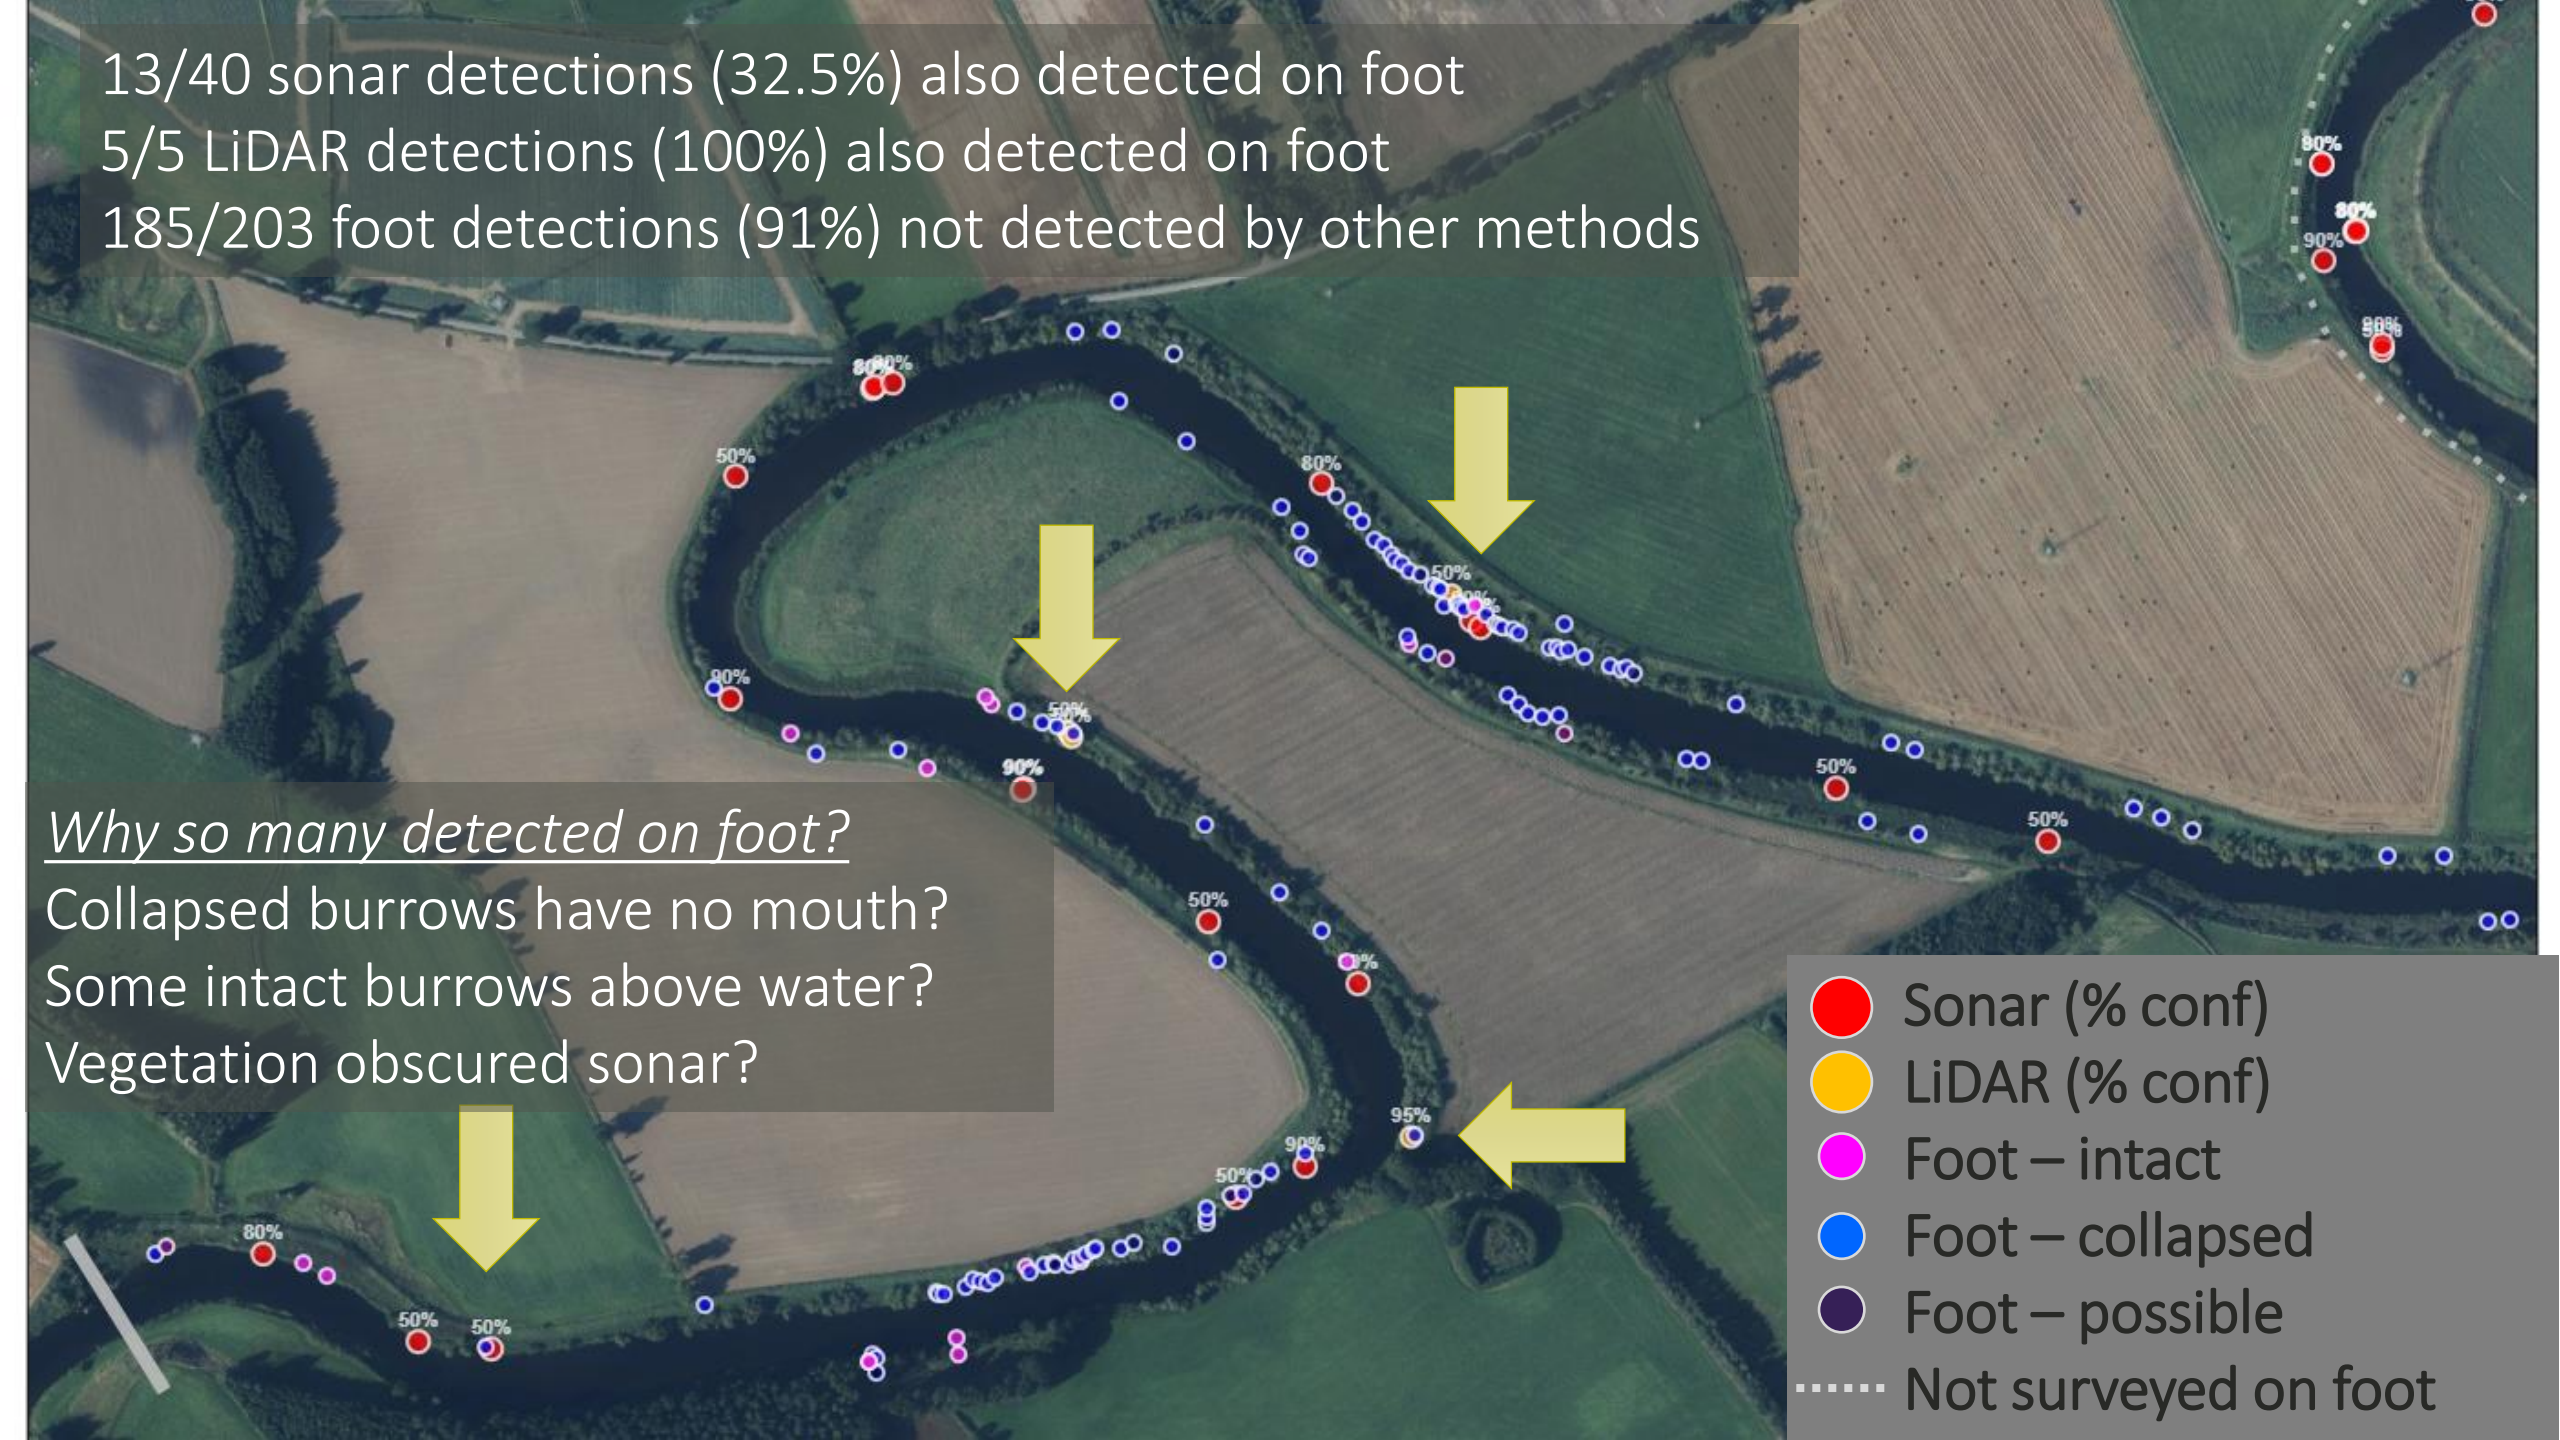
- Sonar (% conf)  
● LiDAR (% conf)  
● Foot – intact  
● Foot – collapsed  
● Foot – possible  
..... Not surveyed on foot

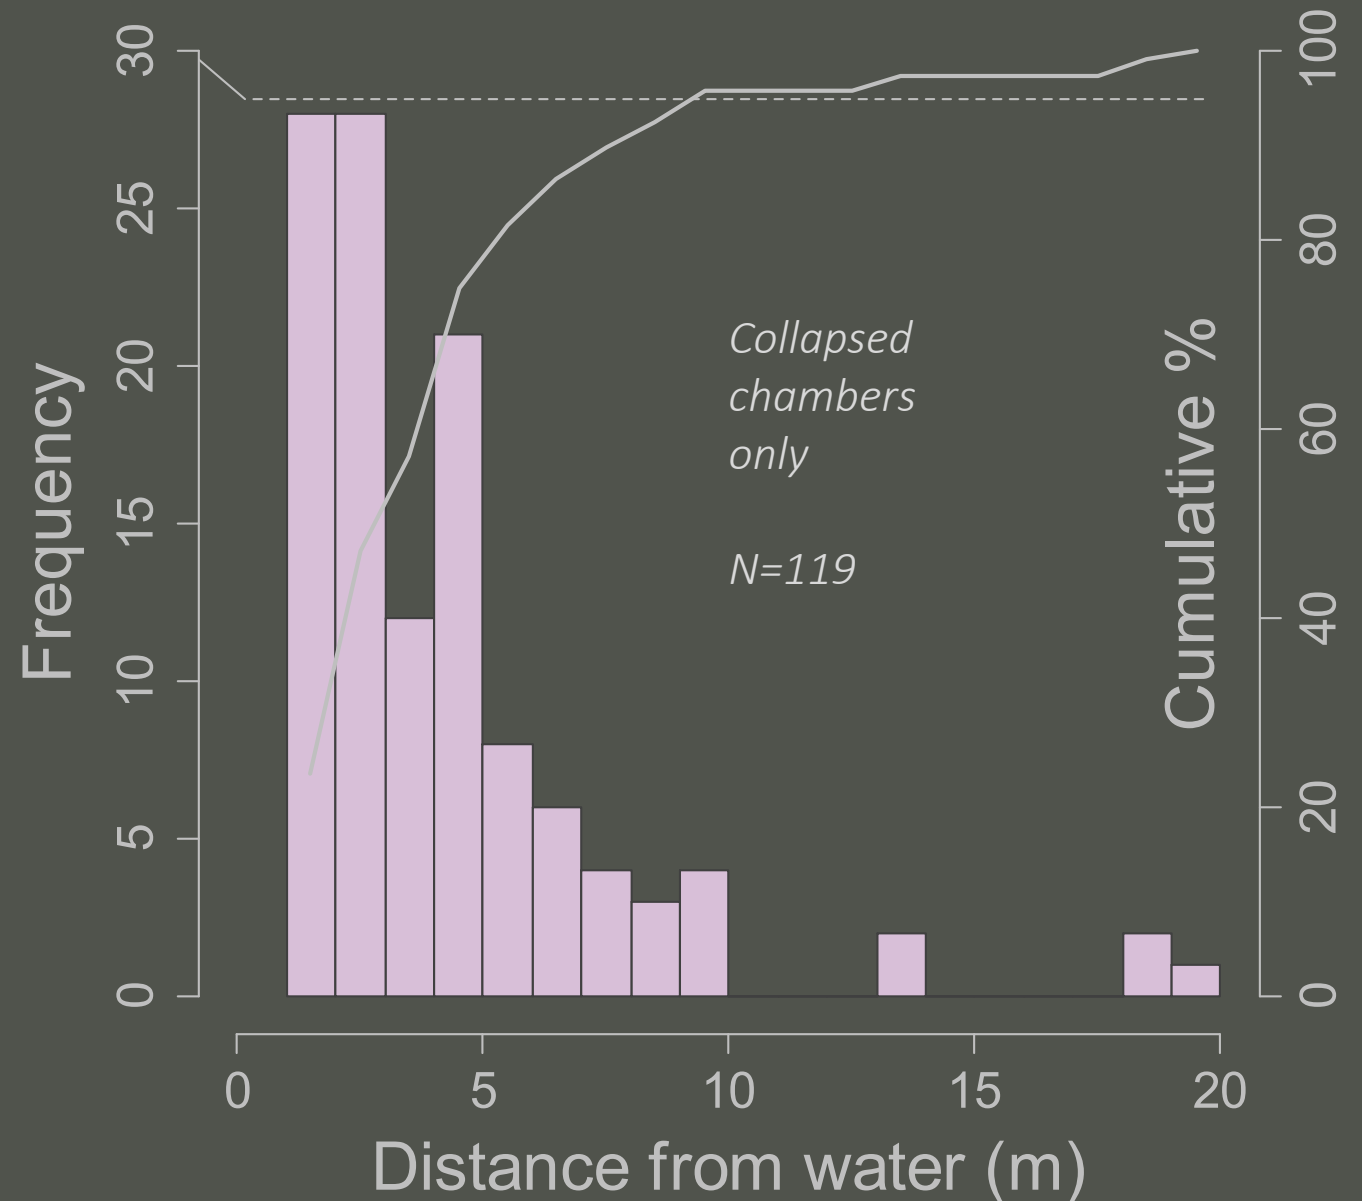
## Histogram of beaver burrow chamber with distance from water

>95% of chambers are <10m from water and none >20m

*But ~1 burrow per 2km river is >10m*

- 95% burrows extended <10m and all <20m
- High number of burrows reflects
  - Long history of occupancy
  - Collapses lead to new digging
  - Removal of beavers may lead to new burrowing?
- Burrows more common with more woody forage and agri land, and steeper banks (offshore at least)
- River meanders not related to burrow frequency
- LiDAR added little compared with foot and sonar (but may do in densely vegetated sites)
- Neither sonar nor foot survey methods detected everything
  - Foot obviously misses many intact burrows with underwater entrances
  - Sonar doesn't detect many collapsed burrows
  - Vegetation may obscure burrows from sonar
